**Historical and Architectural Impact Assessment Report for the
Port Durnford State Forest, Umhlatuze, Uthungulu District
Municipality**

March 2008

archaic consulting

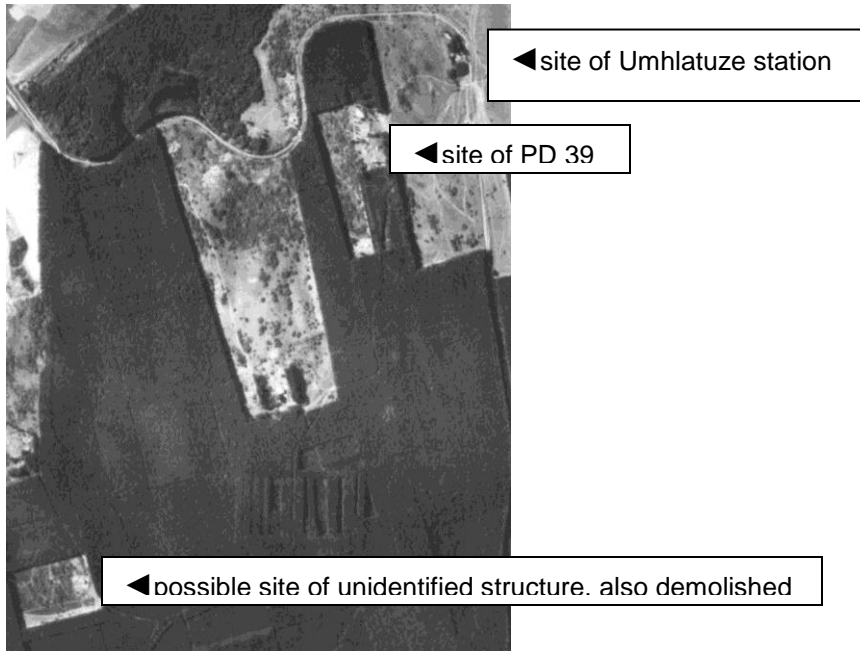
Fig 7: 1937 Aerial photo showing sites correlating to 1930 map in fig 1.

In any event, structures that were demolished and bulldozed on the site date back to pre-1937 (being evident on the photo's) and should not have been demolished without a permit from either *Amafa*, or its progenitor, the National monuments Council.

Condition of site: ruin

Recommendations: since this seems to be the oldest habitation site, the presence of an archaeologist during site clearing is recommended.

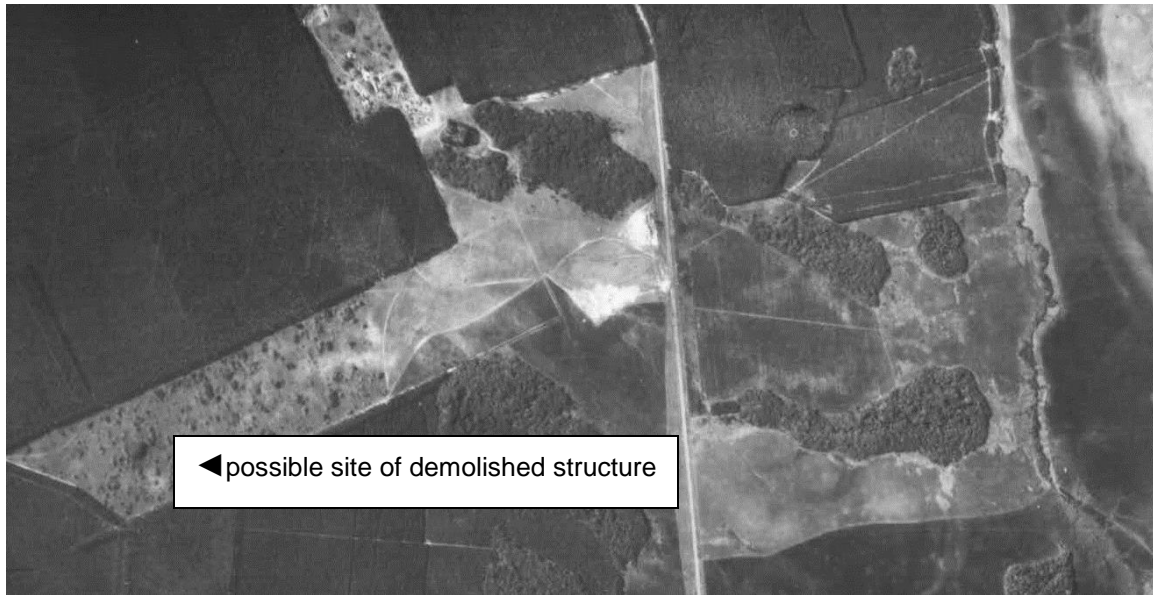
Fig 8: 1937 Aerial photograph showing possible site of PD27

The remains of a dwelling, and concealed rainwater tanks are what is left of this site. The building has been largely destroyed, but some walls still remain to eaves level. The building is of conventional brick and mortar construction, and gauged from the occasional coursing built pre-World War II. No evidence has been found as to what this structure looked like, although its position may be seen on the 1937 aerial photo. (Fig 8)

Condition of site: ruin except for water tanks

Recommendation: none and demolition of the rainwater tanks is recommended

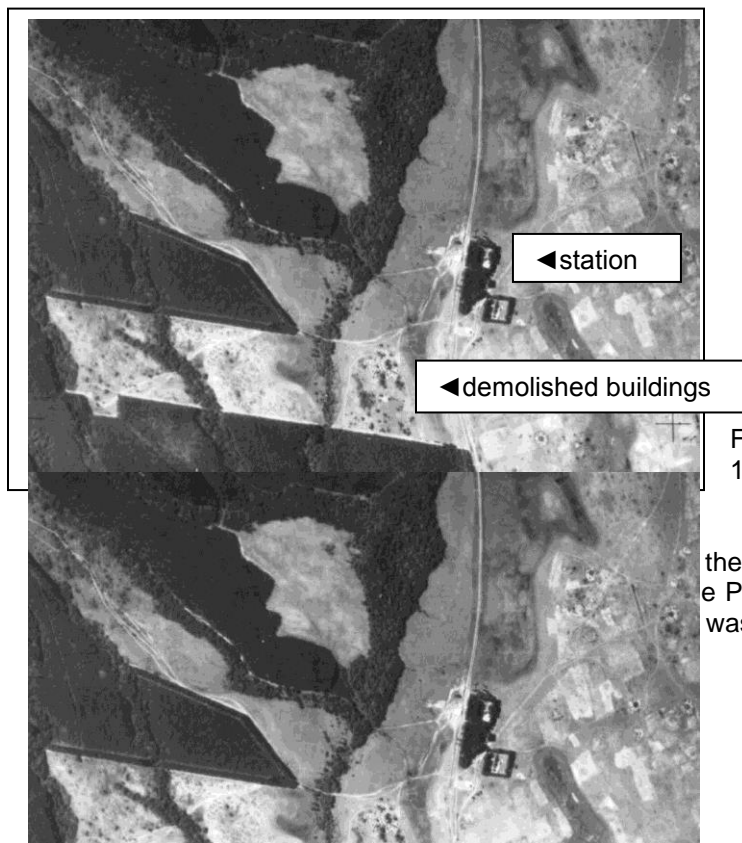
Fig 12: Showing an excerpt from the 1937 aerial photo of the site

The structures that were demolished and bulldozed on the site date back to pre-1937 (being evident on the photo's) and should not have been demolished without a permit from either *Amafa*, or its progenitor, the National Monuments Council.

Condition of site: ruin except for loading ramps

Recommendation: none and demolition of the loading ramps is recommended

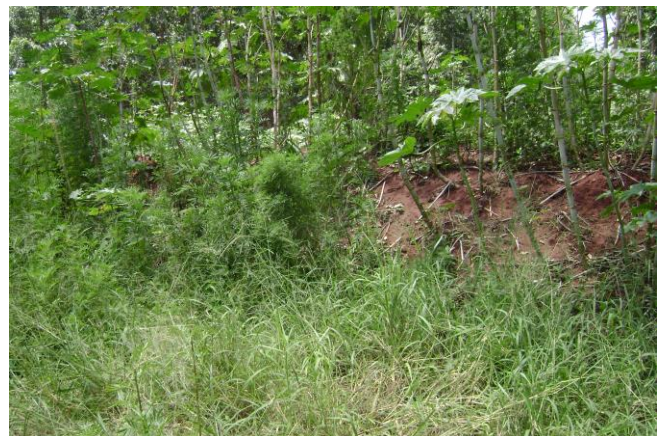
Fig 22: view from road

The structures that were demolished and then bulldozed on the site date back to pre-1937 (being evident on the photo's) and should not have been demolished without a permit from either *Amafa*, or its progenitor, the National Monuments Council.

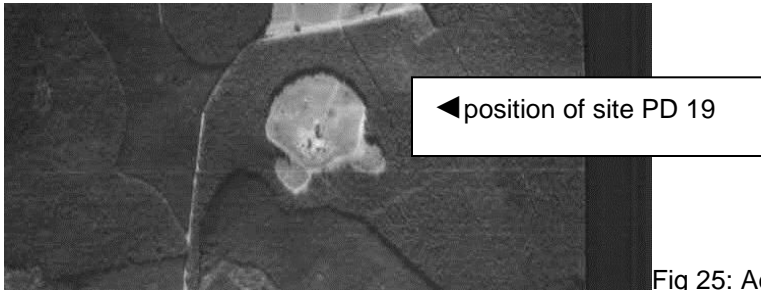
Fig 25: Aerial photo (1937) showing site

Condition of site: overgrown ruin

Recommendation: none

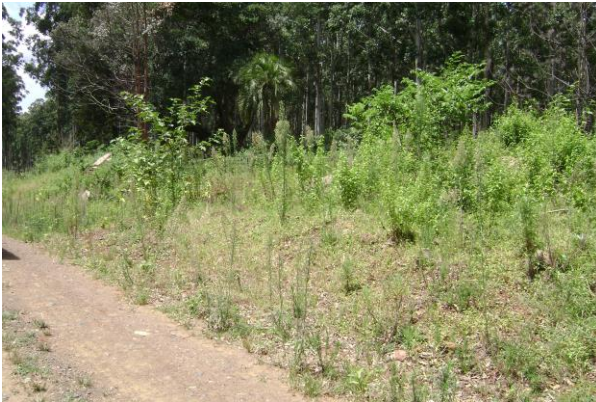
Fig 28: view of site from road

This site is identified as a Forester's encampment on the maps in Fig 2 and 3. Extensive bits of brick walling exist on the surface which has been extensively bulldozed. A water tower still stands.

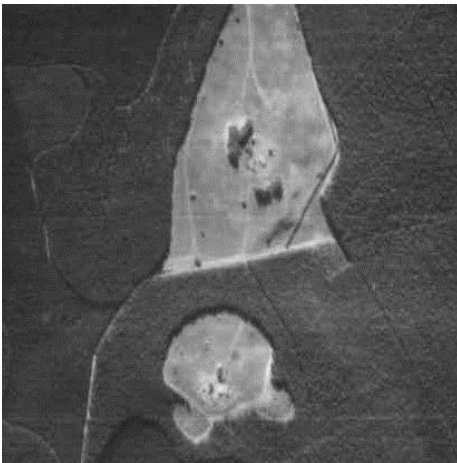
Fig 30: showing site PD 20

The aerial photo to the left (fig 30) shows site PD 19 below and the structure on PD 20 above.

The structures that were demolished and bulldozed on the site date back to pre-1937 (being evident on the photo's) and should not have been demolished without a permit from either *Amafa*, or its progenitor, the National Monuments Council.

Condition of site: overgrown ruin

Recommendation: none

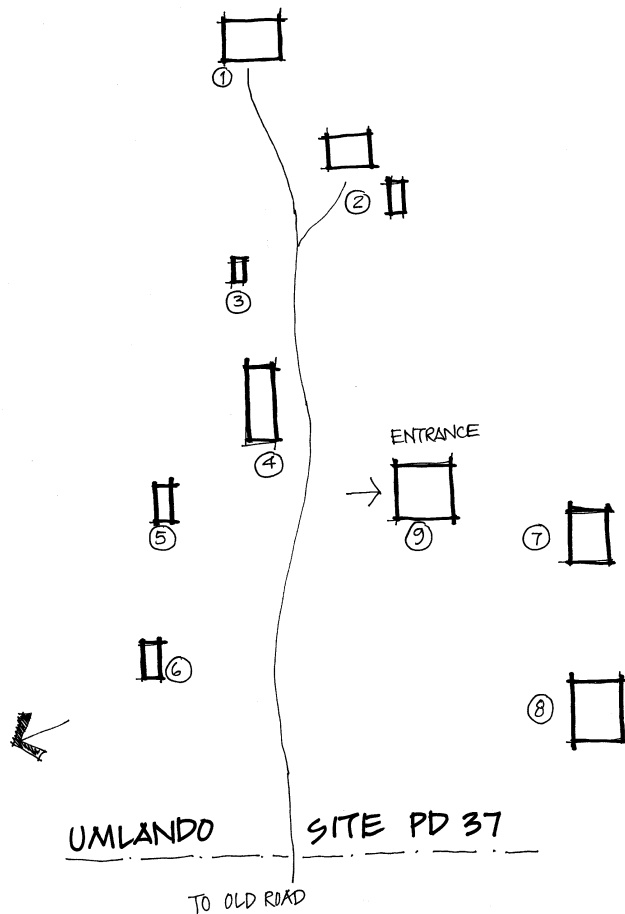
Fig 31: rough sketch showing the layout of the entrance complex

Buildings no 1, 2, 7 and 8 are enclosed housing complexes, largely of latter construction but no 7 likely to fall in within Amafa protection. Building no 3 is a small cottage, possibly built in the 1950's. Building no 4 is a garage complex and has little to merit if except for a large shed. Buildings no 5 and 6 are ill-maintained, ill-inhabited and have little merit, although they are likely to be older than 60 years.

Building no 9 is the entrance building, and is a solid brick structure under Marseille tile. It is also likely to fall within the protection of the Heritage Act no 10 of 1997.

There is no evidence of any of these structures on the 1937 aerial photos.

Condition of site: the buildings are generally in good order. They are architecturally not significant, although they are good examples of functional buildings. They do not operate as a group, do not form streetscape, and are not associated with any major event nor person. They are remote from Empangeni and Mtunzini and their situation limits alternative uses.

Recommendation: should demolition be requested, this group of buildings is not significant with regards to the heritage of the province of KwaZulu-Natal.

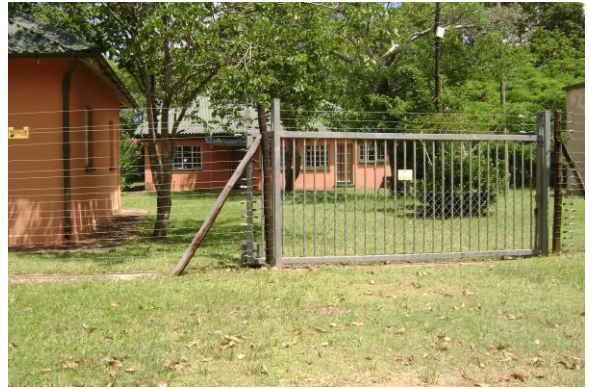
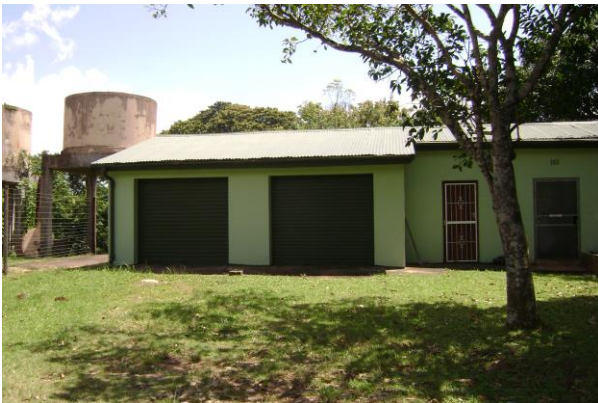
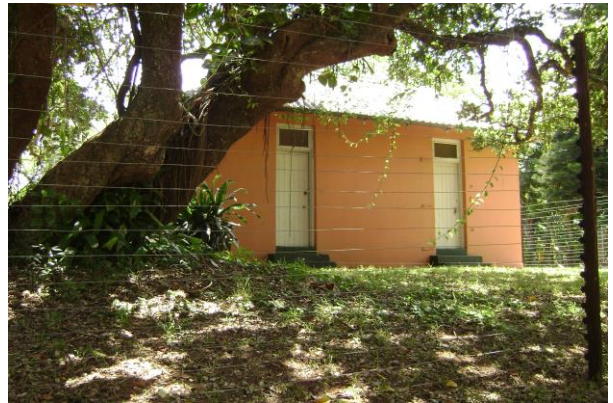
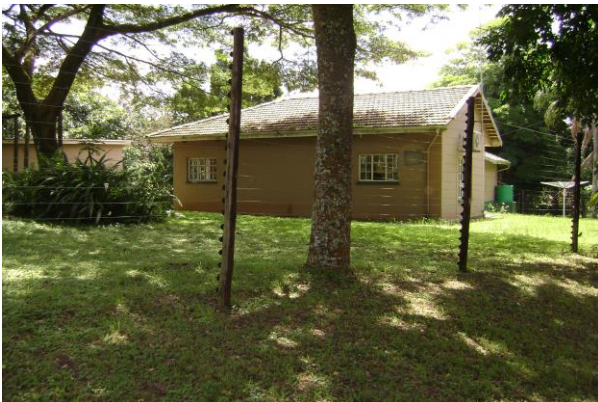
Fig 33: showing part of complex 2

Fig 34: showing part of complex 2

Fig 35: showing part of complex 2

Fig 36: part of complex no 2

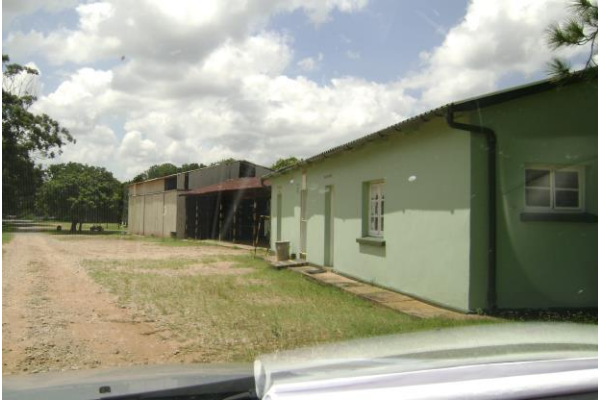
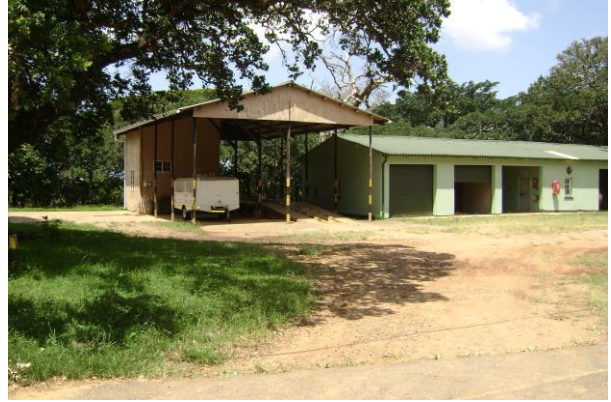
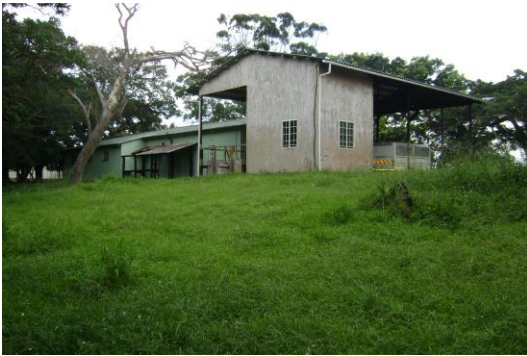
Fig 38: showing complex 4

Fig 39: complex no 4 from the south

Fig 40: showing the north western elevation of the shed in complex 4

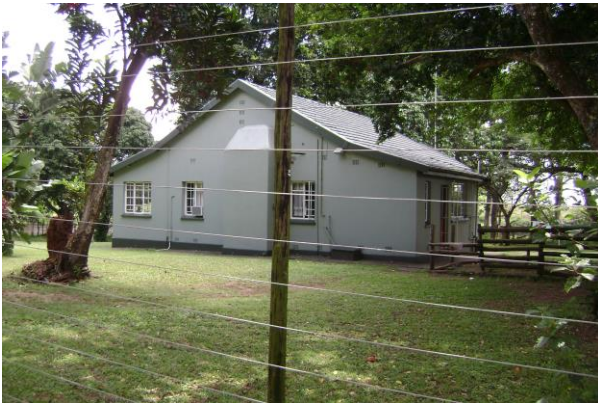
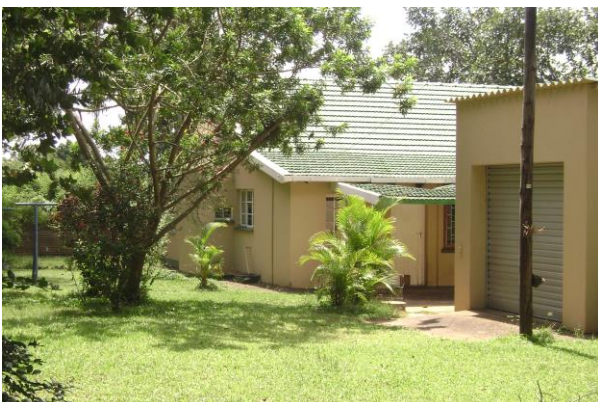
Fig 41: complex no 7

Fig 43: complex number 7

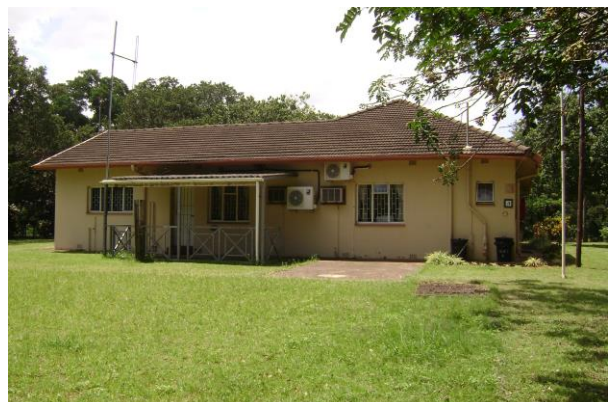
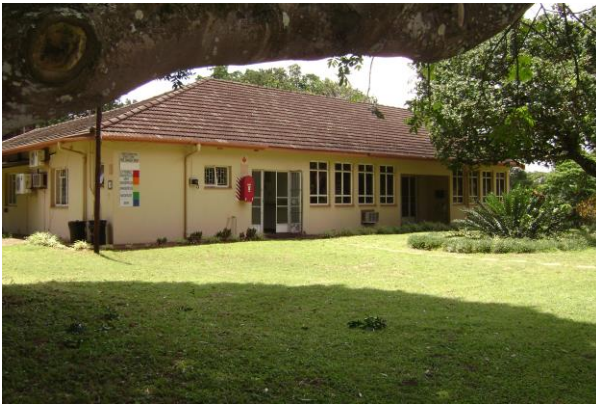
Fig 44: main entrance from the east

Fig 45: Main entrance building from North

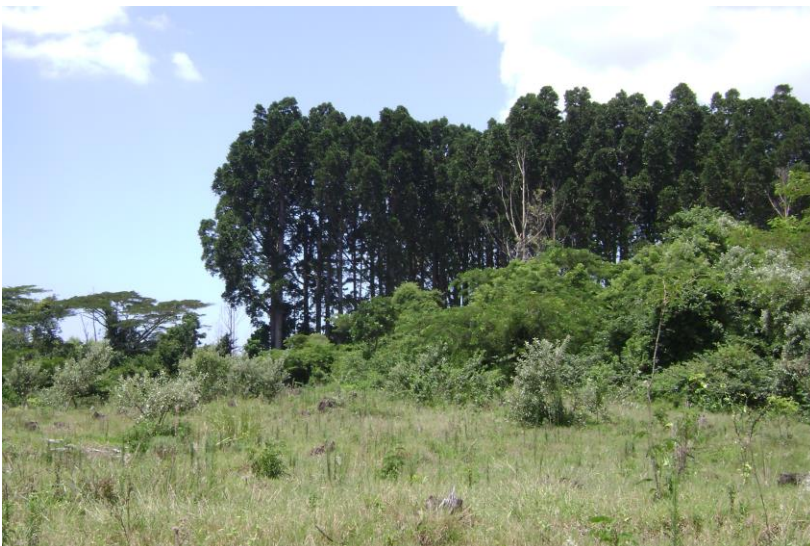
Fig 55: Kauri pines

The author wishes to elicit the support of *Amafa aKwaZulu Natali* for the provisional protection of the large stand of Queensland Kauri Pine (*Agathis Robusta*) which were among the first trees planted at this plantation, before 1920 and which form a unique feature in the history of forestry.
